**OGGETTO: stent – graft dispositivi per chirurgia endovascolare per il trattamento dell'aneurisma -
Prodotto: Nellix® EndoVascular Aneurysm Sealing System (tutti i modelli / numeri di serie) - Invito
alla aumentata sorveglianza dei pazienti già impiantati a seguito dell'azione di richiamo del
dispositivo medico "sistema nellix evas" da parte del fabbricante**

Features associated with Nellix endograft failure

Produced by the independent Nellix Expert Advisory Group to the MHRA, to complement
the following Medical Device Alert:

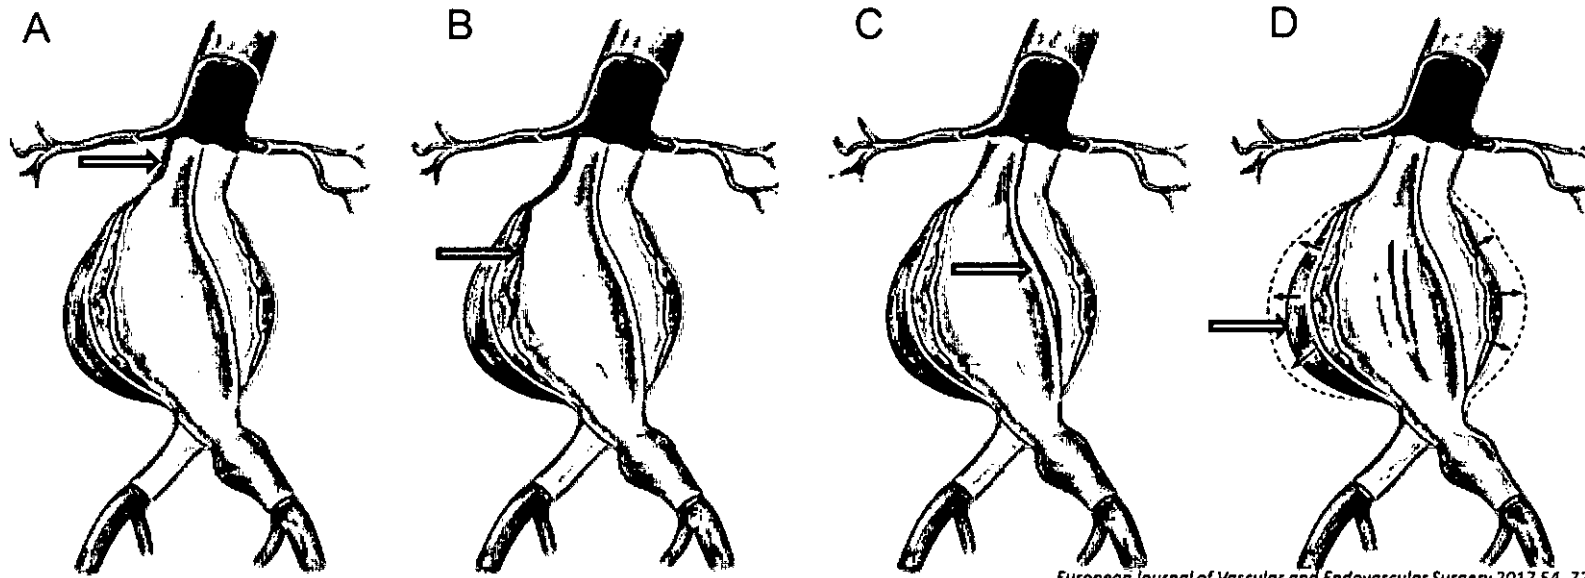
New classification of type 1 leaks with Nellix

(A) Type Is1 endoleak defined as the appearance of contrast between the endobag and the wall of the proximal neck but not reaching the aneurysm sac itself.

(B) Type Is2 endoleak defined as the appearance of contrast between the endobag and aneurysmal wall or thrombus inside the aneurysm sac.

(C) Type Is3 was defined as the appearance of contrast or fresh thrombus between the endobags inside the aneurysm sac.

(D) Type Is4 endoleak defined as the presence of sac pressurisation without proof or with the presence of secondary signs.

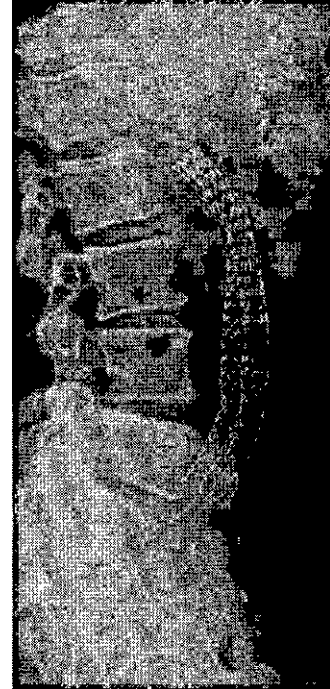
Identifying migration and separation

- Migration can be sometimes be seen on a plain x-ray but only if there is a rigid protocol to control height and orientation between AXRs
- Views: AP & Lateral Abdomen
- On the lateral film make sure you are centred to the centre of the stent graft i.e. able to see about 1-2 vertebral bodies above the stent graft and just reach the top of the femoral heads. It is important to see all of the stent graft. Review previous images for stent position to guide follow ups.

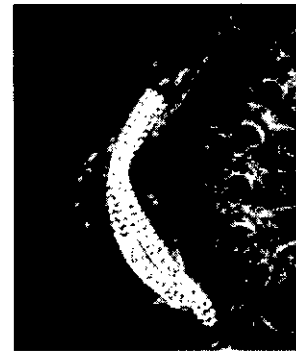
Identifying migration

- Best measured from a fixed landmark such as the SMA or renal artery against the first post-op CT scan
- Migration can be sometimes be seen on a plain x-ray but only if there is a rigid protocol to control height and orientation between AXRs
- Increasing mid stent separation with increased curvature of the stents can be a marker for potential migration

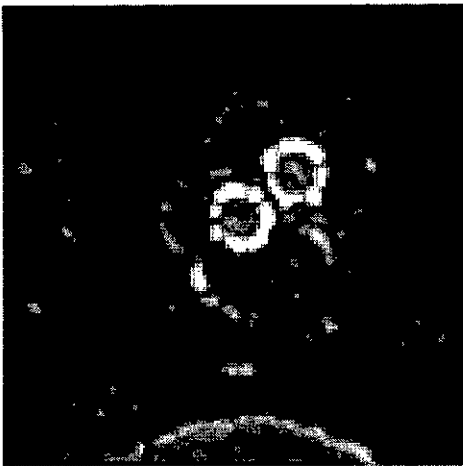
Type 1B endoleaks

Descending axial images showing the lack of bag seal in the distal aorta

- Type 1B leaks are not always easy to spot and their presence may be underestimated
- On early devices the bags were not attached to the distal ends of the stents and so it is not unusual for the bag to remain in the sac and not seal in the iliac vessels. This is not always easy to appreciate
